**Flood Control Project Maintenance
Levee Inspections**

Maintenance Issue Types Only, Levee Inspection Report By Mile - Fall 2015

Reclamation District No. 0544 Upper Roberts Island

Waterway	Bank	Unit Miles	Inspection Start/End	Inspector
Unit No. 01 San Joaquin River	Left	6.05	10/22/2015 10/22/2015	Richard Willoughby

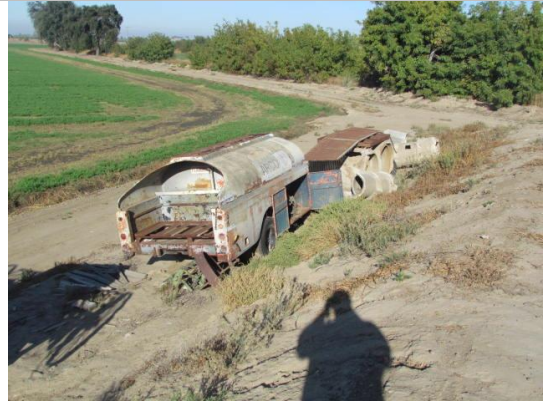
Photo 1 of 5 : FA_2015_RD0544_108_4_20151023_00091.jpg

LM Start	0.06	Rating **	M	Issue No.	4
LM End	0.19	Issue Type +	Ma	Location *	LS
Category	Earthen Levee			GPS Latitude/Longitude	
				Start	End
Item	Encroachments			37.869606 °	37.868163 °
				-121.329571 °	-121.328132 °
DWR ID	DWR_RD0544_01_s_2012_4				
Action/Comments					
Equipment					
Inspector Comments: Farm equipment and supplies stored at landward toe.

Looking west at equipment stored at landward toe fall 2015

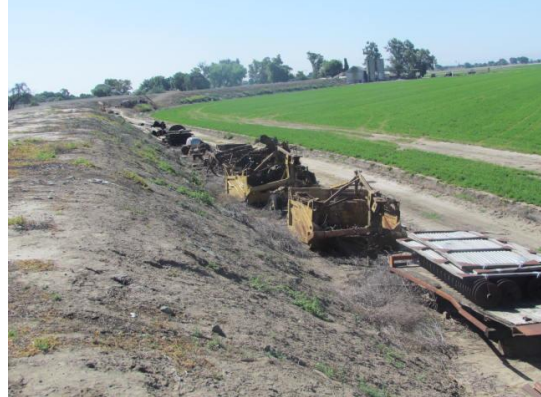
Photo 3 of 5 : FA_2015_RD0544_108_4_20150914_00004.jpg

Looking south at farm equipment at landward toe. (Spring 2015)

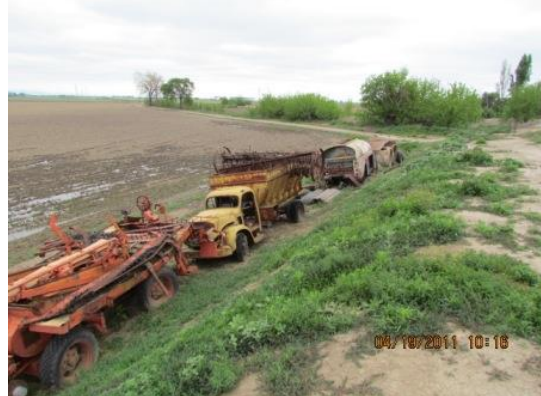
Photo 4 of 5 : FA_2015_RD0544_108_4_20150914_00005.jpg

Looking north at equipment along landside toe.

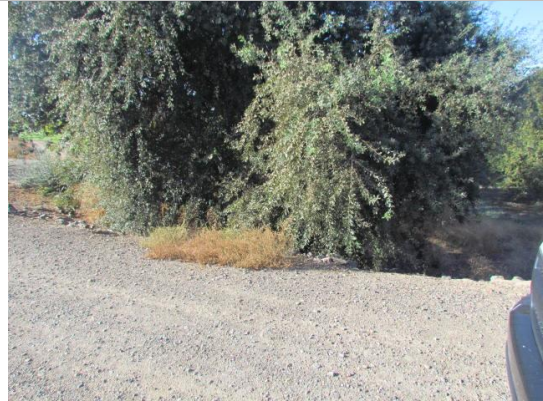
Photo 1 of 1 : FA_2015_RD0544_108_93_20151023_00096.jpg

LM Start	0.81	Rating **	U	Issue No.	93
LM End	0.81	Issue Type +	Ma	Location *	LS
Category	Earthen Levee			GPS Latitude/Longitude	
				Start	End
Item	Trim / Thin Trees			37.862694 °	37.862694 °
				-121.320887 °	-121.320887 °
DWR ID	DWR_RD0544_01_f_2014_93				
Action/Comments					
Trim trees to at least five feet above ground level.

Looking west at untrimmed trees on landward slope and toe fall 2015.

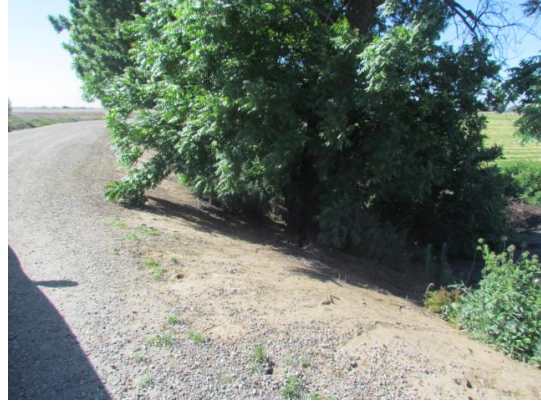
Photo 2 of 2 : FA_2015_RD0544_108_39_20150914_00042.jpg

LM Start	1.12	Rating **	M	Issue No.	39 (cont)
LM End	1.12	Issue Type +	Ma	Location *	LS
Category	Earthen Levee			GPS Latitude/Longitude	
				Start	End
Item	Trim / Thin Trees			37.859423 °	37.859423 °
				-121.318328 °	-121.318328 °
DWR ID	DWR_RD0544_01_s _ 2012_39				
Action/Comments					
Trim trees to at least five feet above ground level. Inspector Comments: Untrimmed trees on landward slope.

Looking southwest at untrimmed tree at landward slope and toe spring 2015

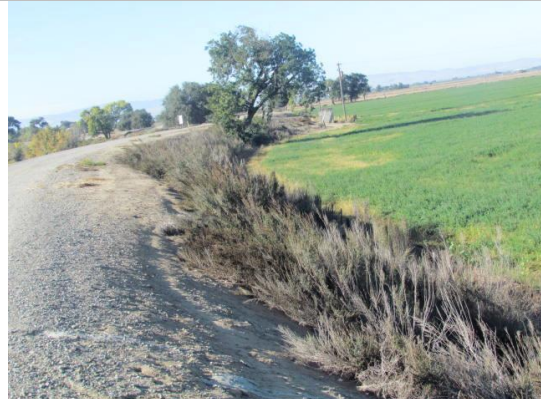
Photo 1 of 1 : FA_2015_RD0544_108_15_20150914_00011.jpg

LM Start	1.13	Rating **	M	Issue No.	15
LM End	1.30	Issue Type +	Ma	Location *	LS
Category	Earthen Levee			GPS Latitude/Longitude	
				Start	End
Item	Vegetation			37.859287 °	37.857322 °
				-121.318333 °	-121.319985 °
DWR ID	DWR_RD0544_01_s _ 2012_15				
Action/Comments					
Remove the wild growth other than native grasses from the levee slopes.

Looking southeast at dense vegetation on landward toe.

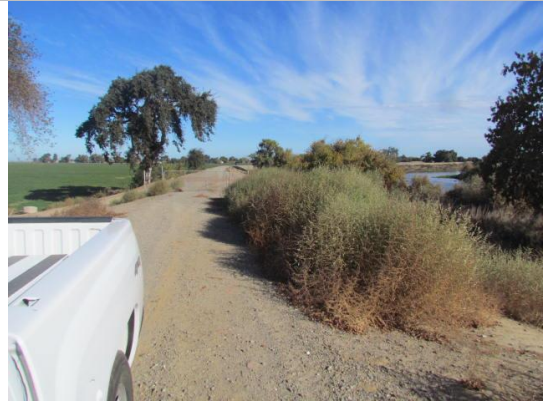
Photo 1 of 1 : FA_2015_RD0544_108_94_20150914_00067.jpg

LM Start	1.48	Rating **	A/W	Issue No.	94
LM End	1.50	Issue Type +	Ma	Location *	WS
Category	Earthen Levee			GPS Latitude/Longitude	
				Start	End
Item	Vegetation			37.855097 °	37.854722 °
				-121.321136 °	-121.321072 °
DWR ID	DWR_RD0544_01_f_2014_94				
Action/Comments					
Remove the wild growth other than native grasses from the levee slopes.					
Inspector Comments: Issue has been corrected, but should be monitored.

Looking north at vegetation on waterward shoulder and slope.

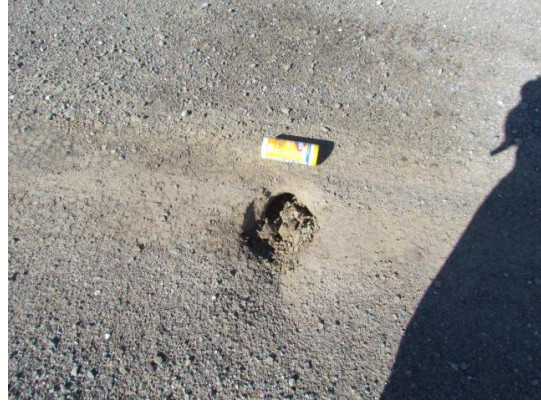
Photo 1 of 2 : FA_2015_RD0544_108_90_20150914_00063.jpg

LM Start	2.01	Rating **	A/W	Issue No.	90
LM End	2.01	Issue Type +	Ma	Location *	CR
Category	Earthen Levee			GPS Latitude/Longitude	
				Start	End
Item	Animal Control			37.850825 °	37.850825 °
				-121.322475 °	-121.322475 °
DWR ID	DWR_RD0544_01_s _ 2014_90				
Action/Comments					
No rodents visible, but rodent burrows visible; need to backfill and compact or grout burrows. Inspector Comments: LMA grouted rodent hole on levee crown.

Looking at rodent hole on levee crown.

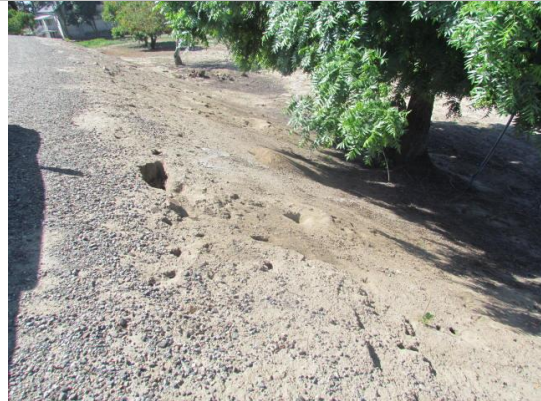
Photo 1 of 2 : FA_2015_RD0544_108_34_20150914_00038.jpg

LM Start	2.32	Rating **	M	Issue No.	34
LM End	2.36	Issue Type +	Ma	Location *	LS
Category	Earthen Levee			GPS Latitude/Longitude	
				Start	End
Item	Animal Control			37.847292 °	37.846743 °
				-121.324662 °	-121.324336 °
DWR ID	DWR_RD0544_01_s _ 2012_34				
Action/Comments					
Exterminate rodents and backfill and compact or grout burrows. Inspector Comments: Several rodent hole within this reach.

Looking south at several rodent holes on landward shoulder and slope.

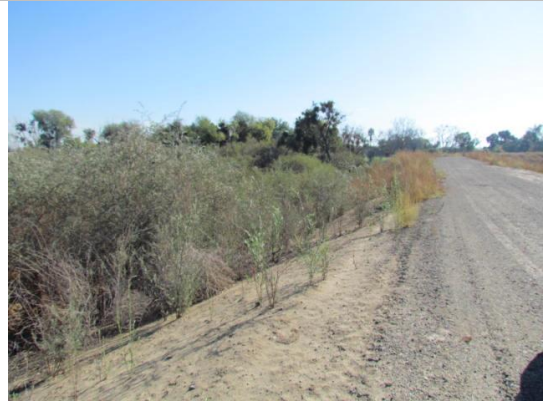
Photo 1 of 1 : FA_2015_RD0544_108_106_20151023_00106.jpg

LM Start	2.89	Rating **	U	Issue No.	106
LM End	3.16	Issue Type +	Ma	Location *	WS
Category	Earthen Levee			GPS Latitude/Longitude	
				Start	End
Item	Vegetation			37.840952 °	37.837588 °
				-121.319327 °	-121.317540 °
DWR ID	DWR_RD0544_01_s _ 2015_106				
Action/Comments					
Remove the wild growth other than native grasses from the levee slopes.					
Inspector Comments: Dense williows and vegetation waterward slope.

Looking southeast at dense willows (veg) on waterward slope and toe fall 2015.

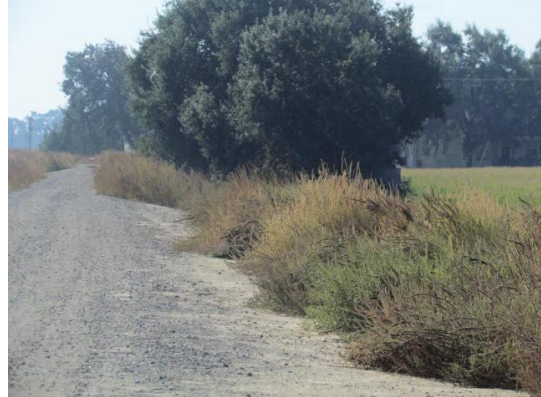
Photo 1 of 1 : FA_2015_RD0544_108_47_20151023_00107.jpg

LM Start	2.95	Rating **	U	Issue No.	47
LM End	3.19	Issue Type +	Ma	Location *	LS
Category	Earthen Levee			GPS Latitude/Longitude	
				Start	End
Item	Vegetation			37.840485 °	37.837225 °
				-121.318390 °	-121.317408 °
DWR ID	DWR_RD0544_01_s_2012_47				
Action/Comments					
Remove the wild growth other than native grasses from the levee slopes.

Looking south at dense veg on landward slope fall 2015.

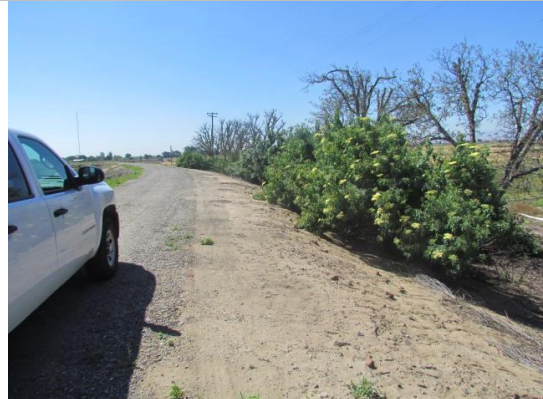
Photo 1 of 1 : FA_2015_RD0544_108_49_20150914_00045.jpg

LM Start	3.22	Rating **	M	Issue No.	49
LM End	3.84	Issue Type +	Ma	Location *	WS
Category	Earthen Levee			GPS Latitude/Longitude	
				Start	End
Item	Vegetation			37.836763 °	37.829195 °
				-121.317307 °	-121.311918 °
DWR ID	DWR_RD0544_01_s _ 2012_49				
Action/Comments					
Remove the wild growth other than native grasses from the levee slopes.

Looking southwest at untrimmed trees at landward toe.

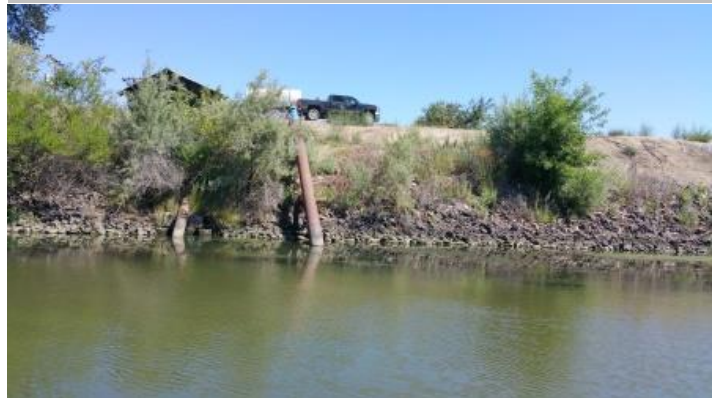
Photo 1 of 2 : SJR2015_RD0544U01RM51.04_1.JPG

LM Start	4.23	Rating **	M	Issue No.	46
LM End	4.24	Issue Type +	Ma	Location *	WS
Category	Supplemental			GPS Latitude/Longitude	
				Start	End
Item	DWR Erosion Survey			37.825248 °	37.825248 °
				-121.313856 °	-121.313856 °
DWR ID					
Action/Comments					
Inspector Comments: 06/24/2015: No significant change observed. 06/19/2014: No significant change observed. 08/13/2013: The erosion has been caused by irrigation pipe. [2015 Site ID:RD0544U01RM51.04]

Front view of the site.

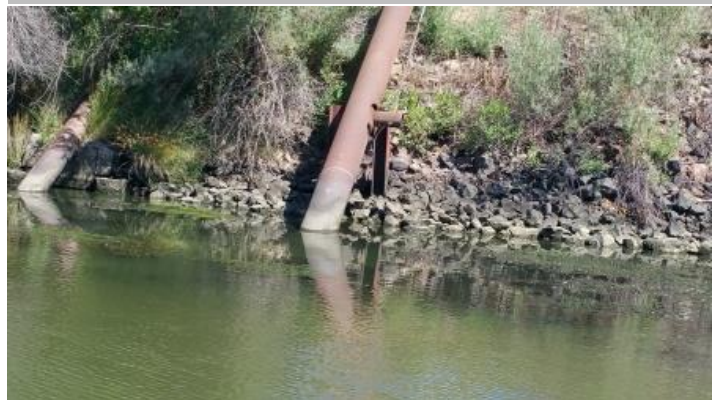
Photo 2 of 2 : SJR2015_RD0544U01RM51.04_4.JPG

Close view of the site.

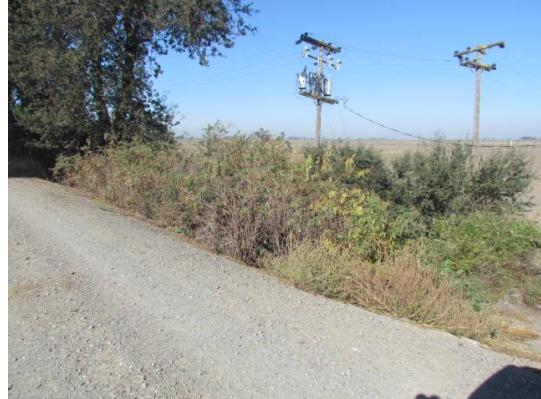
Photo 1 of 1 : FA_2015_RD0544_108_57_20151023_00108.jpg

LM Start	4.24	Rating **	U	Issue No.	57
LM End	4.49	Issue Type +	Ma	Location *	LS
Category	Earthen Levee			GPS Latitude/Longitude	
				Start	End
Item	Vegetation			37.825517 °	37.822955
				-121.314160 °	-121.316835
DWR ID	DWR_RD0544_01_s _ 2012_57				
Action/Comments					
Elderberries are blocking visibility and flood fight capability. Inspector Comments: Dense elderberry on landward slope and toe.

Looking southwest at dense elderberries on landward slope fall 2015.

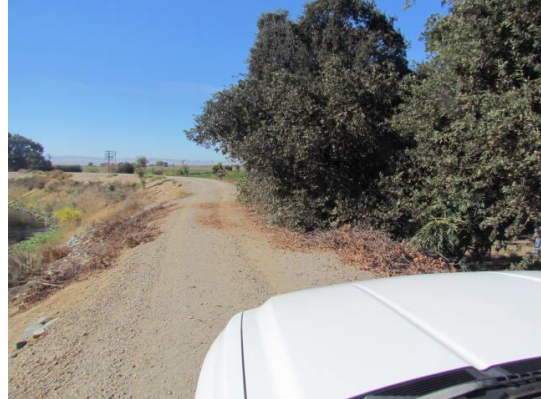
Photo 1 of 1 : FA_2015_RD0544_108_105_20150914_00071.jpg

LM Start	4.69	Rating **	U	Issue No.	105
LM End	4.69	Issue Type +	Ma	Location *	LS
Category	Earthen Levee			GPS Latitude/Longitude	
				Start	End
Item	Trim / Thin Trees			37.821775 °	37.821775
				-121.320203 °	-121.320203
DWR ID	DWR_RD0544_01_f_2014_105				
Action/Comments					
Thin trees to allow visibility of the ground and room to flood fight. Inspector Comments: Tree has overgrown onto levee crown.

Looking south at overgrown tree on landward shoulder.

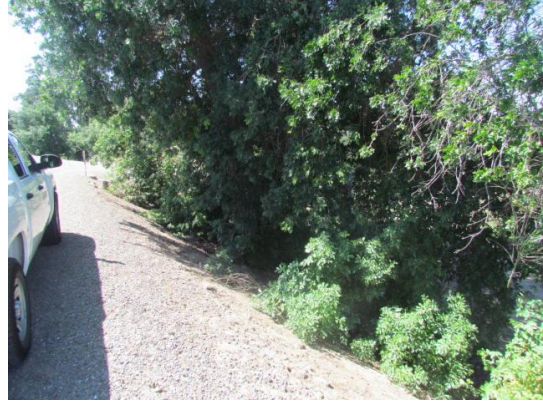
Photo 1 of 1 : FA_2015_RD0544_108_112_20150914_00074.jpg

LM Start	4.77	Rating **	U	Issue No.	112
LM End	4.77	Issue Type +	Ma	Location *	LS
Category	Earthen Levee			GPS Latitude/Longitude	
				Start	End
Item	Trim / Thin Trees			37.820828 °	37.820828 °
				-121.321193 °	-121.321193 °
DWR ID	DWR_RD0544_01_s _ 2015_112				
Action/Comments					
Trim trees to at least five feet above ground level.

Looking southwest at dense trees on landward slope and toe.

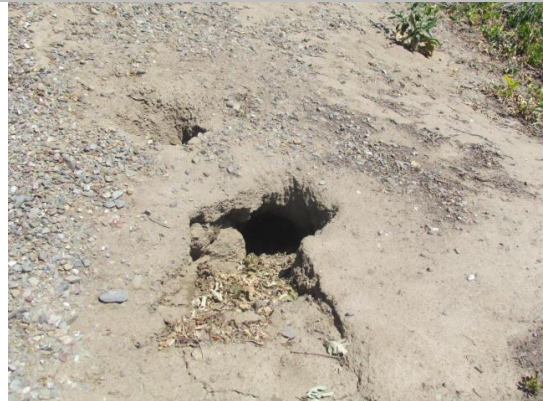
Photo 1 of 1 : FA_2015_RD0544_108_113_20150914_00075.jpg

LM Start	4.77	Rating **	U	Issue No.	113
LM End	4.77	Issue Type +	Ma	Location *	WS
Category	Earthen Levee			GPS Latitude/Longitude	
				Start	End
Item	Erosion / Bank Caving			37.820828 °	37.820828 °
				-121.321193 °	-121.321193 °
DWR ID	DWR_RD0544_01_s _ 2015_113				
Action/Comments					
Note and monitor erosion site. Inspector Comments: Large hole, possibly a rodent hole, on waterward slope.

Looking north at large hole on waterward slope.

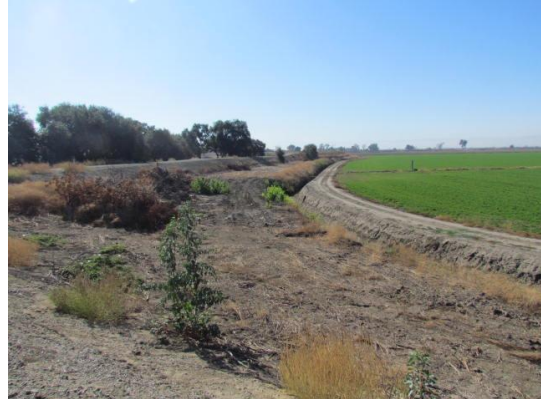
Photo 1 of 2 : FA_2015_RD0544_108_33_20151023_00115.jpg

LM Start	4.95	Rating **	A/W	Issue No.	33
LM End	5.26	Issue Type +	Ma	Location *	LS
Category	Earthen Levee			GPS Latitude/Longitude	
				Start	End
Item	Vegetation			37.818718 °	37.814662 °
				-121.319508 °	-121.320302 °
DWR ID	DWR_RD0544_01_s _ 2012_33				
Action/Comments					
Remove the wild growth other than native grasses from the levee slopes. Inspector Comments: Vegetation has been sprayed, and it should be monitored.

Looking southwest at cleared landward slope and berm fall 2015.

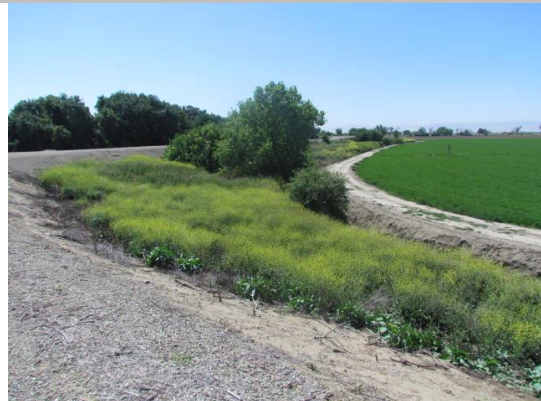
Photo 2 of 2 : FA_2015_RD0544_108_33_20150914_00033.jpg

Looking southwest at dense vegetation at landward slope and toe.(Spring 2015)

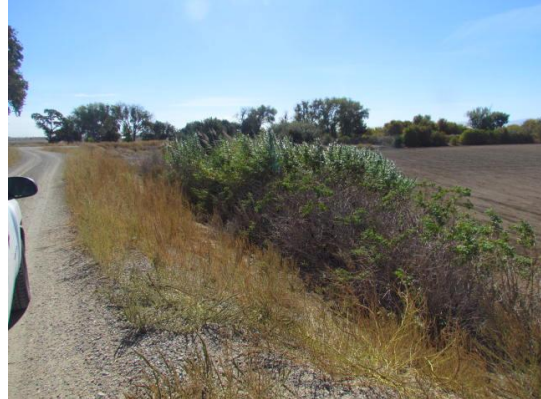
Photo 1 of 1 : FA_2015_RD0544_108_35_20150914_00040.jpg

LM Start	5.34	Rating **	M	Issue No.	35
LM End	5.34	Issue Type +	Ma	Location *	LS
Category	Earthen Levee			GPS Latitude/Longitude	
				Start	End
Item	Vegetation			37.813659 °	37.813659 °
				-121.319614 °	-121.319614 °
DWR ID	DWR_RD0544_01_s _ 2012_35				
Action/Comments					
Remove the wild growth other than native grasses from the levee slopes. Inspector Comments: LMA corrected site, but some vegetation still exists.

Looking south at bamboo on landward slope and toe.

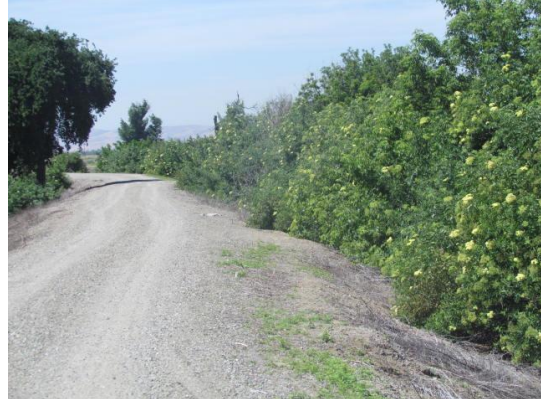
Photo 1 of 2 : FA_2015_RD0544_108_18_20150914_00024.jpg

LM Start	5.49	Rating **	U	Issue No.	18
LM End	5.55	Issue Type +	Ma	Location *	LS
Category	Earthen Levee			GPS Latitude/Longitude	
				Start	End
Item	Vegetation			37.812033 °	37.811687 °
				-121.319737 °	-121.320677 °
DWR ID	DWR_RD0544_01_s _ 2012_18				
Action/Comments					
Elderberries are blocking visibility and flood fight capability. Inspector Comments: Elderberry exists on the slope of the levee.

Looking south at dense vegetation on landward slope and toe.(Spirng 2015)

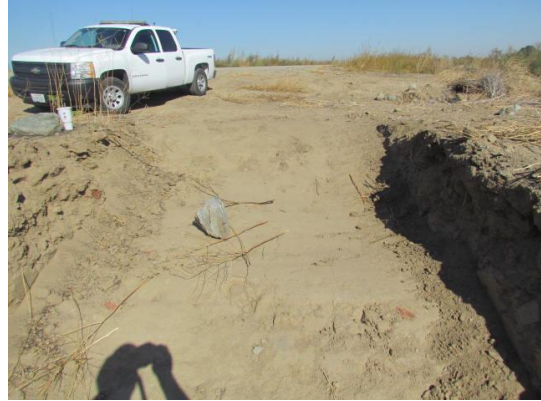
Photo 1 of 4 : FA_2015_RD0544_108_121_20151023_00109.jpg

LM Start	5.60	Rating **	U	Issue No.	121
LM End	5.60	Issue Type +	Ma	Location *	WS
Category	Earthen Levee			GPS Latitude/Longitude	
				Start	End
Item	Erosion / Bank Caving			37.811234 °	37.811234 °
				-121.321412 °	-121.321412 °
DWR ID	DWR_RD0544_01_f_2015_121				
Action/Comments					
Schedule repair of erosion site prior to the next inspection. Inspector Comments: Someone digging/excavating on waterward berm. Excavation in 3ft wide and eighteen inches deep and ten feet long.

Looking west at excavation on waterward berm.

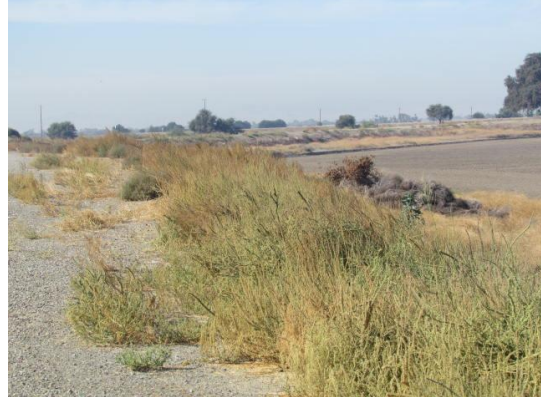
Photo 1 of 2 : FA_2015_RD0544_109_3_20151026_00063.jpg

Looking south at dense veg on landward slope and toe fall 2015.

LM Start	0.03	Rating **	U	Issue No.	3
LM End	0.17	Issue Type +	Ma	Location *	LS
Category	Earthen Levee			GPS Latitude/Longitude	
				Start	End
Item	Vegetation			37.808603 °	37.808213 °
				-121.328719 °	-121.331241 °
DWR ID	DWR_RD0544_02_s _ 2012_3				
Action/Comments					
Remove the wild growth other than native grasses from the levee slopes.

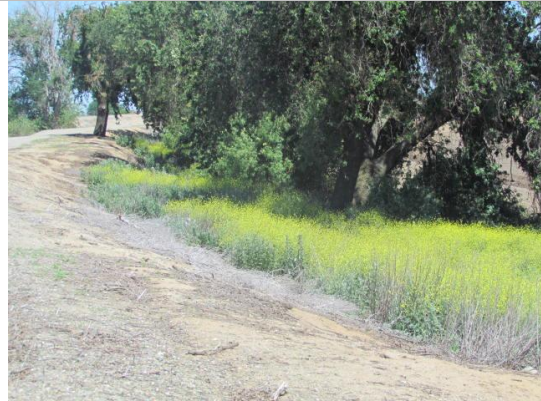
Photo 1 of 1 : FA_2015_RD0544_109_1_20150914_00001.jpg

Looking southwest at dense vegetation at landward toe.

LM Start	0.43	Rating **	M	Issue No.	1
LM End	1.12	Issue Type +	Ma	Location *	LS
Category	Earthen Levee			GPS Latitude/Longitude	
				Start	End
Item	Vegetation			37.810250 °	37.819452 °
				-121.334933 °	-121.333755 °
DWR ID	DWR_RD0544_02_s _ 2012_1				
Action/Comments					
Remove the wild growth other than native grasses from the levee slopes.

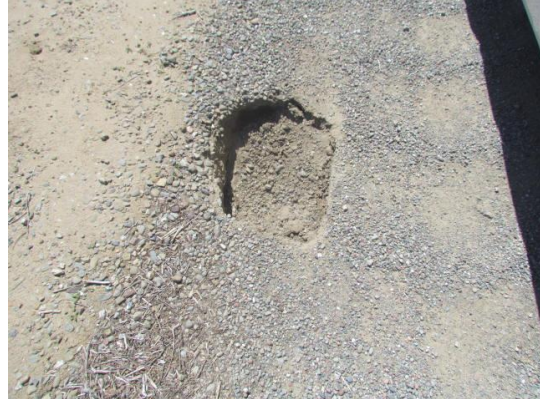
Photo 1 of 1 : FA_2015_RD0544_109_46_20150914_00044.jpg

LM Start	0.64	Rating **	U	Issue No.	46
LM End	0.64	Issue Type +	Ma	Location *	LS
Category	Earthen Levee			GPS Latitude/Longitude	
				Start	End
Item	Erosion / Bank Caving			37.813197 °	37.813197 °
				-121.335055 °	-121.335055 °
DWR ID	DWR_RD0544_02_s _ 2015_46				
Action/Comments					
Note and monitor erosion site. Inspector Comments: Depression greater than one inch deep and greater than three inches on landward shoulder

Looking at depression on landward shoulder.

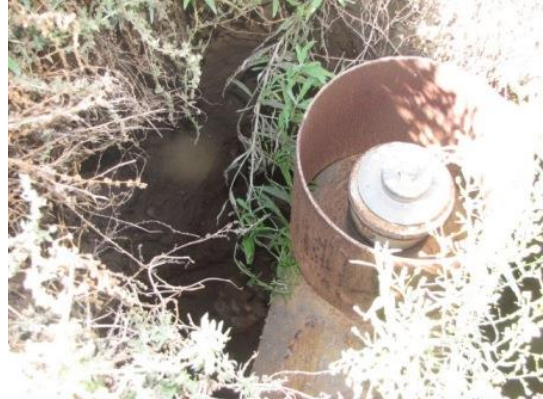
Photo 2 of 8 : FA_2015_RD0544_109_8_20150914_00009.jpg

Looking at caving around 10" siphon pipe on waterside shoulder.

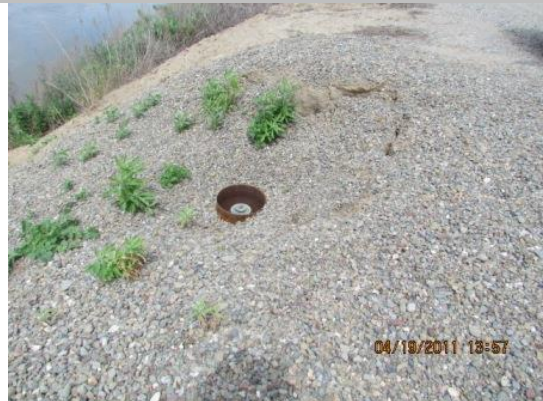
Photo 3 of 8 : FA_2015_RD0544_109_8_20150914_00010.jpg

Looking south at depression greater than 6" on waterside shoulder.

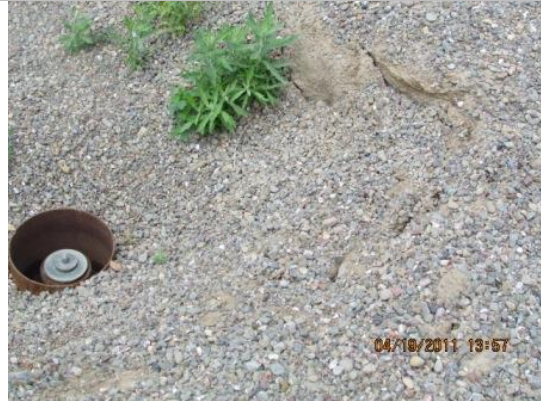
Photo 5 of 8 : FA_2015_RD0544_109_8_20150914_00012.jpg

LM Start	0.78	Rating **	U	Issue No.	8 (cont)
LM End	0.78	Issue Type +	Ma	Location *	WS
Category	Interior Drainage & Piping Systems			GPS Latitude/Longitude	
				Start	End
Item	Erosion Areas			37.815094 °	37.815094 °
				-121.333927 °	-121.333927 °
DWR ID	DWR_RD0544_02_s _ 2012_8				
Action/Comments					
Inspector Comments: Caving under and around siphon on waterside shoulder. No material 3' below pipe. Caving around siphon is 20" to 24" deep approximately 72" in diameter. During 2012 spring inspection hole appears to be enlarging.

Looking at top of siphon with a depression greater than 6" on waterside shoulder.

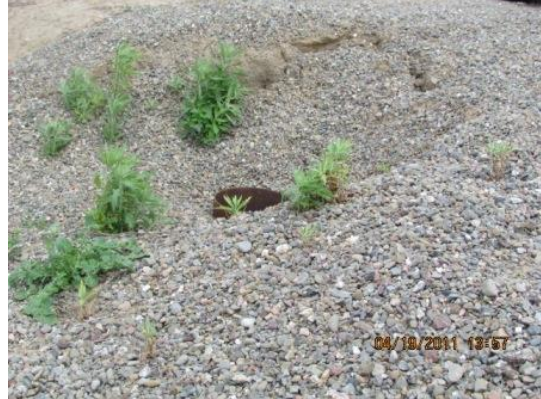
Photo 8 of 8 : FA_2015_RD0544_109_8_20150914_00015.jpg

LM Start	0.78	Rating **	U	Issue No.	8 (cont)	
LM End	0.78	Issue Type +	Ma	Location *	WS	
Category	Interior Drainage & Piping Systems			GPS Latitude/Longitude		
				Start		End
Item	Erosion Areas			37.815094 °		37.815094 °
				-121.333927 °		-121.333927 °
DWR ID	DWR_RD0544_02_s_2012_8					
Action/Comments						
Inspector Comments: Caving under and around siphon on waterside shoulder. No material 3' below pipe. Caving around siphon is 20" to 24" deep approximately 72" in diameter. During 2012 spring inspection hole appears to be enlarging.

Looking south at depression greater than 6" around siphon on waterside shoulder.

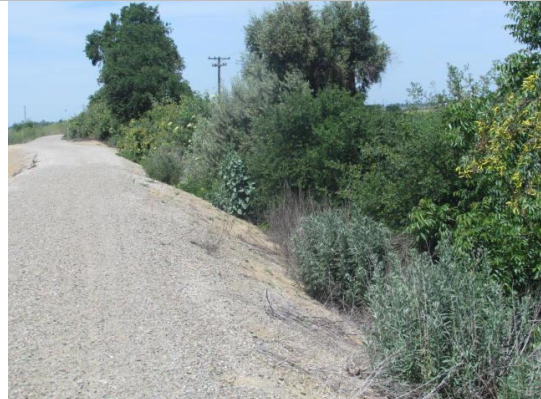
Photo 1 of 2 : FA_2015_RD0544_109_49_20150914_00045.jpg

LM Start	1.30	Rating **	U	Issue No.	49
LM End	1.40	Issue Type +	Ma	Location *	WS
Category	Earthen Levee			GPS Latitude/Longitude	
				Start	End
Item	Vegetation			37.820767 °	37.821582 °
				-121.336611 °	-121.338102 °
DWR ID	DWR_RD0544_02_f_2014_49				
Action/Comments					
Remove the wild growth other than native grasses from the levee slopes.					
Inspector Comments: Tobacco plants on waterward slope.

Looking southwest at dense vegetation on landward slope and toe.

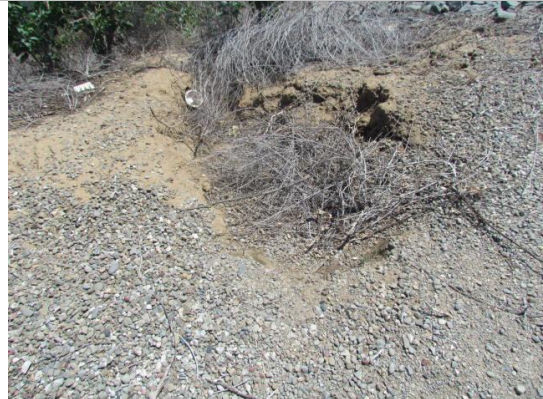
Photo 1 of 2 : FA_2015_RD0544_109_38_20150914_00041.jpg

LM Start	1.86	Rating **	U	Issue No.	38
LM End	1.86	Issue Type +	Ma	Location *	WS
Category	Earthen Levee			GPS Latitude/Longitude	
				Start	End
Item	Erosion / Bank Caving			37.817983 °	37.817983 °
				-121.341682 °	-121.341682 °
DWR ID	DWR_RD0544_02_s _ 2015_38				
Action/Comments					
Note and monitor erosion site. Inspector Comments: Erosion/Caving on waterward shoulder and slope 18" x 6" x 15'.

Looking southeast at erosion/caving on waterward slope.

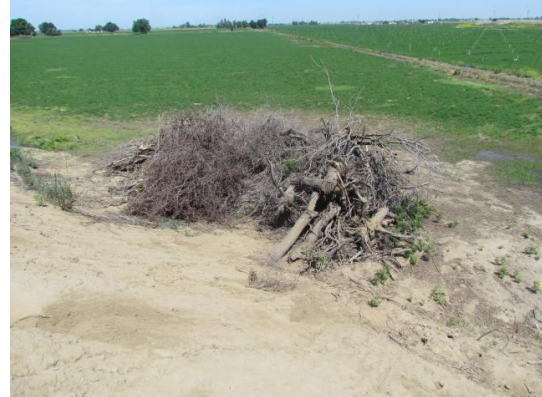
Photo 1 of 1 : FA_2015_RD0544_109_57_20150914_00050.jpg

LM Start	2.02	Rating **	U	Issue No.	57
LM End	2.02	Issue Type +	Ma	Location *	LS
Category	Earthen Levee			GPS Latitude/Longitude	
				Start	End
Item	Encroachments			37.818853 °	37.818853 °
				-121.343473 °	-121.343473 °
DWR ID	DWR_RD0544_02_s _ 2015_57				
Action/Comments					
Prunings					
Inspector Comments: Large pruning pile at landward toe.

Looking west at pruning pile at landward toe.(Spring 2015)

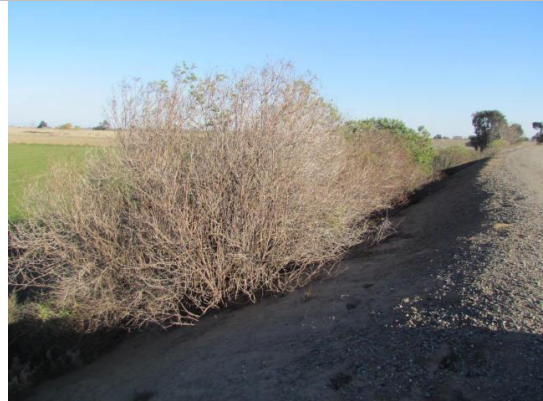
Photo 1 of 1 : FA_2015_RD0544_109_13_20150914_00020.jpg

LM Start	2.07	Rating **	M	Issue No.	13
LM End	2.09	Issue Type +	Ma	Location *	LS
Category	Earthen Levee			GPS Latitude/Longitude	
				Start	End
Item	Vegetation			37.819337 °	37.819460 °
				-121.344275 °	-121.344492 °
DWR ID	DWR_RD0544_02_s_2012_13				
Action/Comments					
Elderberries are blocking visibility and flood fight capability.

Looking northwest at elderberries on landside slope and toe.

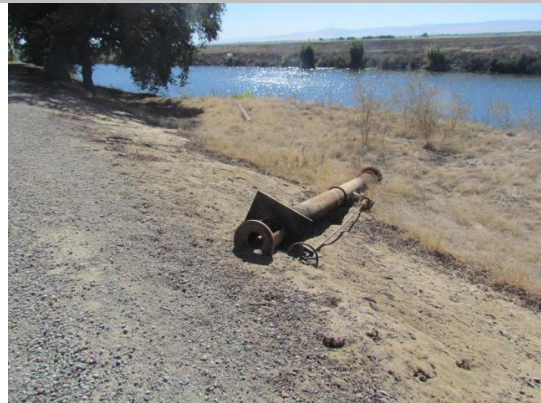
Photo 1 of 1 : FA_2015_RD0544_109_50_20150914_00047.jpg

LM Start	2.21	Rating **	M	Issue No.	50
LM End	2.21	Issue Type +	Ma	Location *	WS
Category	Earthen Levee			GPS Latitude/Longitude	
				Start	End
Item	Encroachments			37.820646 °	37.820646 °
				-121.346014 °	-121.346014 °
DWR ID	DWR_RD0544_02_f _ 2014_50				
Action/Comments					
Garbage					
Inspector Comments: Discarded intake pipe on waterward slope.

Looking northwest at pipe on waterward slope.

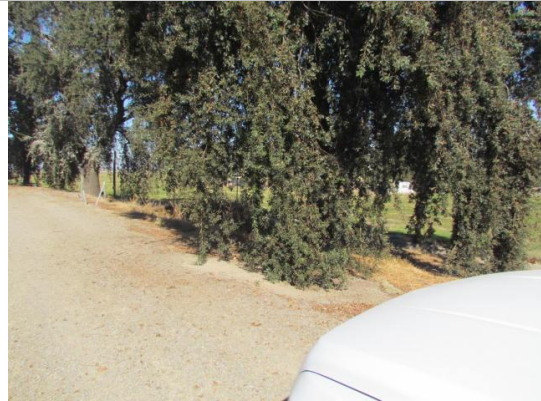
Photo 1 of 1 : FA_2015_RD0544_109_61_20151026_00066.jpg

LM Start	2.28	Rating **	U	Issue No.	61
LM End	2.28	Issue Type +	Ma	Location *	LS
Category	Earthen Levee			GPS Latitude/Longitude	
				Start	End
Item	Trim / Thin Trees			37.821473 °	37.821473 °
				-121.346860 °	-121.346860 °
DWR ID	DWR_RD0544_02_s _ 2015_61				
Action/Comments					
Trim trees to at least five feet above ground level.					
Inspector Comments: Untrimmed tree on landward shoulder.

Looking west at untrimmed trees on landward slope fall 2015.

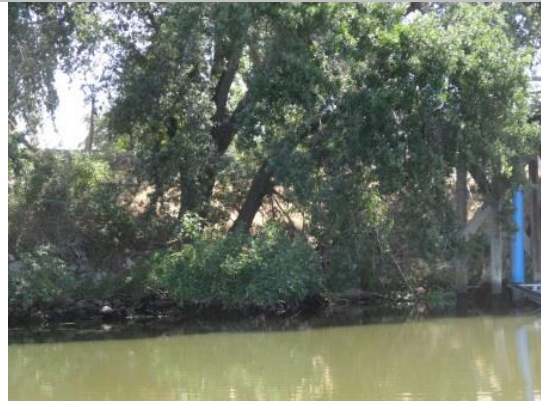
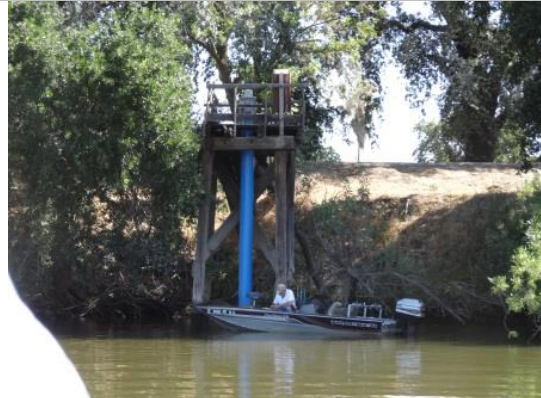
Photo 1 of 2 : SJR2015_RD0544U02RM33.21_2.jpg

LM Start	2.31	Rating **	M	Issue No.	12
LM End	2.31	Issue Type +	Ma	Location *	WS
Category	Supplemental			GPS Latitude/Longitude	
				Start	End
Item	DWR Erosion Survey			37.821763 °	37.821763 °
				-121.347275 °	-121.347275 °
DWR ID					
Action/Comments					
Inspector Comments: 06/25/2015: No significant change observed. 07/02/2014: No significant change observed. 08/20/2013: No significant change observed. 08/07/2012: The site was first reported in 2012 spring levee inspection report. The data were estimated as the site is underneath a irrigation pump station and inaccessible by boat or land survey. It's possible the pump station played a role in the erosion. [2015 Site ID:RD0544U02RM33.21]

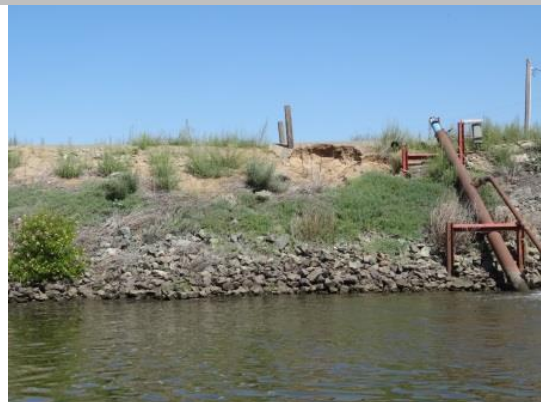
Photo 1 of 3 : SJR2015_RD0544U02RM33.00_4.JPG

LM Start	2.61	Rating **	U	Issue No.	9
LM End	2.61	Issue Type +	Ma	Location *	WS
Category	Supplemental			GPS Latitude/Longitude	
				Start	End
Item	DWR Erosion Survey			37.818861 °	37.818861 °
				-121.350400 °	-121.350400 °
DWR ID	DWR_RD0544_02_f _ 2015_9				
Action/Comments					
Inspector Comments: 06/25/2015: The site was discovered during the boat survey. Irrigation pipe leakage caused the soil to sink at the upper levee shoulder. The lower part of the levee is protected by riprap rocks. The irrigation pump was operating at the site. [2015 Site ID:RD0544U02RM33]

Front view of the erosion site.

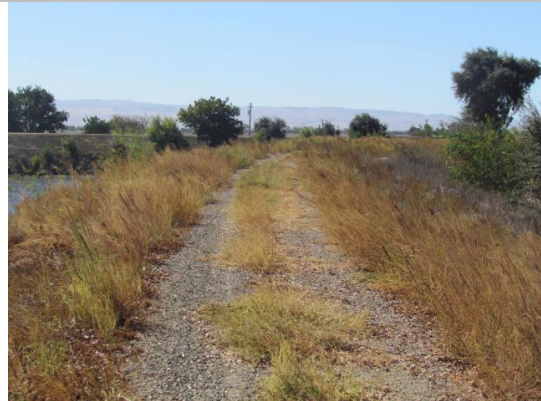
Photo 1 of 1 : FA_2015_RD0544_109_52_20150914_00049.jpg

Looking south at vegetation on levee crown.

LM Start	2.69	Rating **	A/W	Issue No.	52
LM End	3.20	Issue Type +	Ma	Location *	CR
Category	Earthen Levee			GPS Latitude/Longitude	
				Start	End
Item	Vegetation			37.817928 °	37.818824 °
				-121.351355 °	-121.359523 °
DWR ID	DWR_RD0544_02_f_2014_52				
Action/Comments					
Remove the wild growth other than native grasses from the levee slopes.

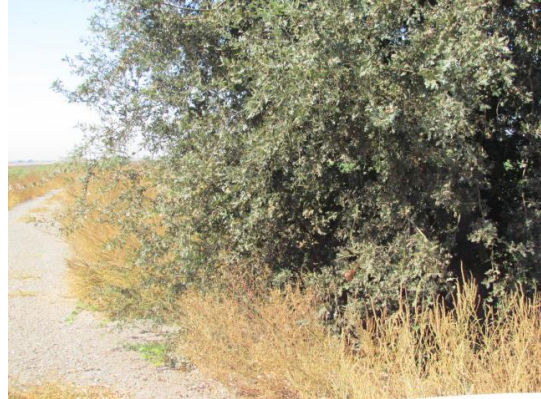
Photo 1 of 1 : FA_2015_RD0544_109_53_20151026_00073.jpg

Looking southwest at untrimmed tree on landward slope fall 2015.

LM Start	2.80	Rating **	U	Issue No.	53
LM End	2.80	Issue Type +	Ma	Location *	LS
Category	Earthen Levee			GPS Latitude/Longitude	
				Start	End
Item	Trim / Thin Trees			37.817187 °	37.817187 °
				-121.352964 °	-121.352964 °
DWR ID	DWR_RD0544_02_f_2014_53				
Action/Comments					
Thin trees to allow visibility of the ground and room to flood fight.

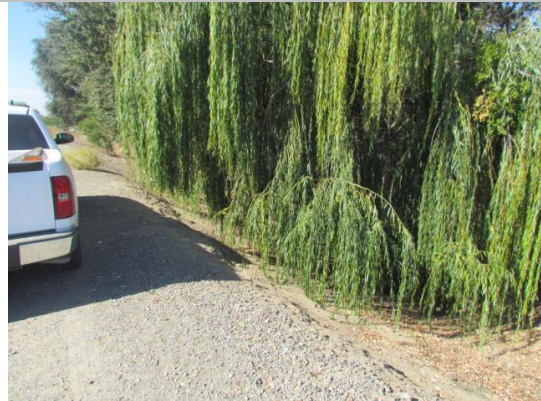
Photo 1 of 1 : FA_2015_RD0544_109_55_20151026_00075.jpg

Looking southwest at untrimmed trees on landward slope and toe fall 2015.

LM Start	3.49	Rating **	U	Issue No.	55
LM End	3.52	Issue Type +	Ma	Location *	LS
Category	Earthen Levee			GPS Latitude/Longitude	
				Start	End
Item	Trim / Thin Trees			37.819563 °	37.819542 °
				-121.364307 °	-121.364908 °
DWR ID	DWR_RD0544_02_f_2014_55				
Action/Comments					
Thin trees to allow visibility of the ground and room to flood fight.

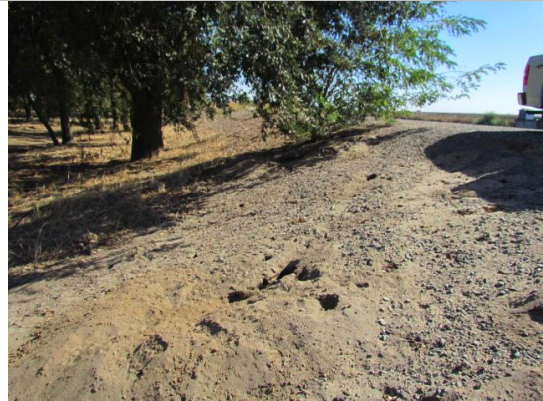
Photo 1 of 2 : FA_2015_RD0544_109_67_20151026_00078.jpg

LM Start	3.58	Rating **	U	Issue No.	67
LM End	3.58	Issue Type +	Ma	Location *	LS
Category	Earthen Levee			GPS Latitude/Longitude	
				Start	End
Item	Animal Control			37.819419 °	37.819419
				-121.365854 °	-121.365854
DWR ID	DWR_RD0544_02_f_2015_67				
Action/Comments					
Exterminate rodents and backfill and compact or grout burrows. Inspector Comments: Large rodent holes on landward slope.

Looking northeast at typical view of rodent holes on landward slope.
